# **INDOOR AIR QUALITY ASSESSMENT**

**Dennett Elementary School  
80 Crescent Street  
Plympton, Massachusetts**

Prepared by:  
Massachusetts Department of Public Health  
Bureau of Environmental Health Assessment  
Emergency Response/Indoor Air Quality Program  
January 2004

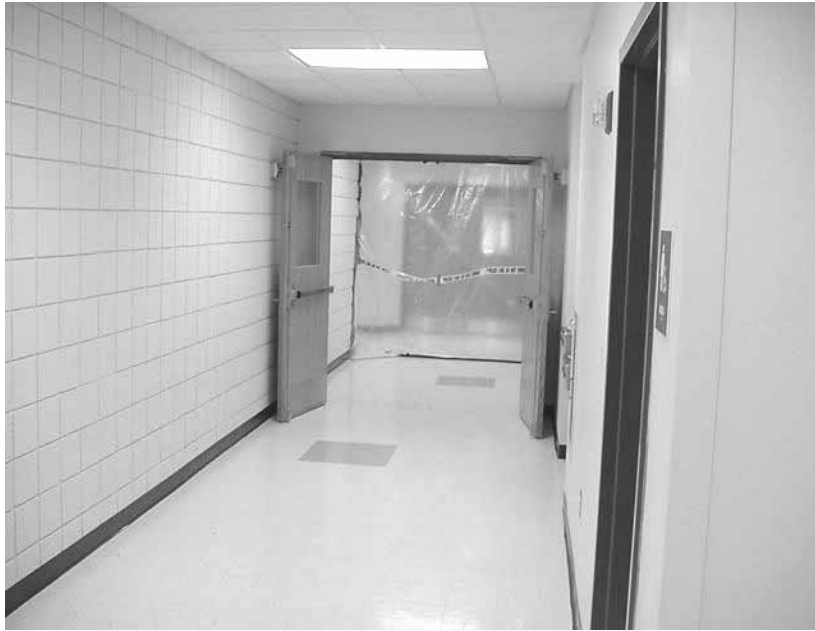
**Picture 1**

**Polyethylene Plastic and Duct Tape Barriers Erected inside Hallways**

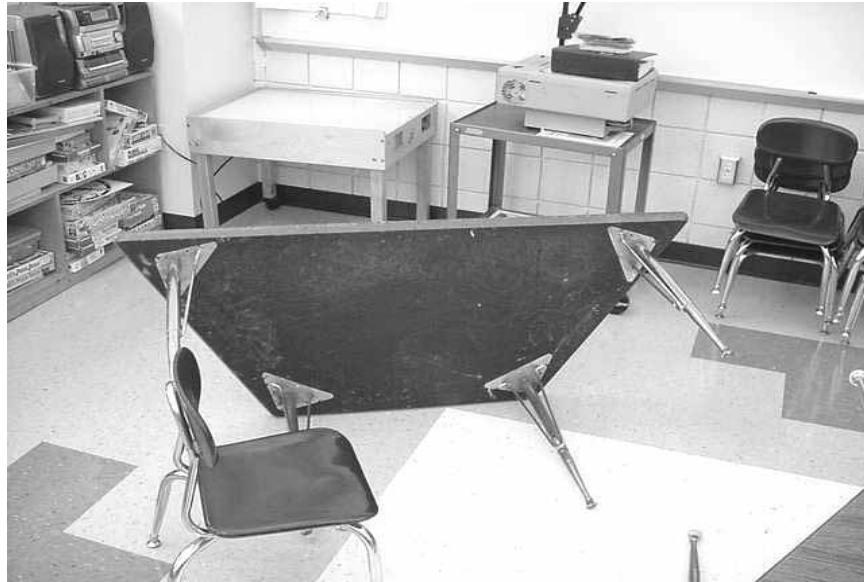
**Picture 2**

BEHA staff observed mold colonization on a variety of building materials. Non-porous surfaces [e.g., tables (Picture 2)] were coated with materials (e.g., dust) that can support microbial growth if exposed to moisture for extended periods. Porous materials sustaining water damage include gypsum wallboard (GW), ceiling tiles and pipe insulation (Pictures 3-5). Water damage/mold growth appeared to be on materials that were part of or in close proximity to chilled water components of the ventilation system (e.g. pipe insulation).

**Table Coated with Surface Mold Colonies**

2. Clean non-porous surfaces with an appropriate antimicrobial agent. Wash treated surface with soap and water to remove residues.
3. Consider consulting a building engineer to determine the effects of water damage to chilled water pipe and univent insulation. Remediate as needed.
4. Insulate the condensation pump in the ceiling of the library to prevent future condensation.
5. Seal spaces in exterior wall around condensation drains.
6. Seal seam at cement/exterior wall junction outside air room.
7. Activate exhaust ventilation system to aid in moisture removal.

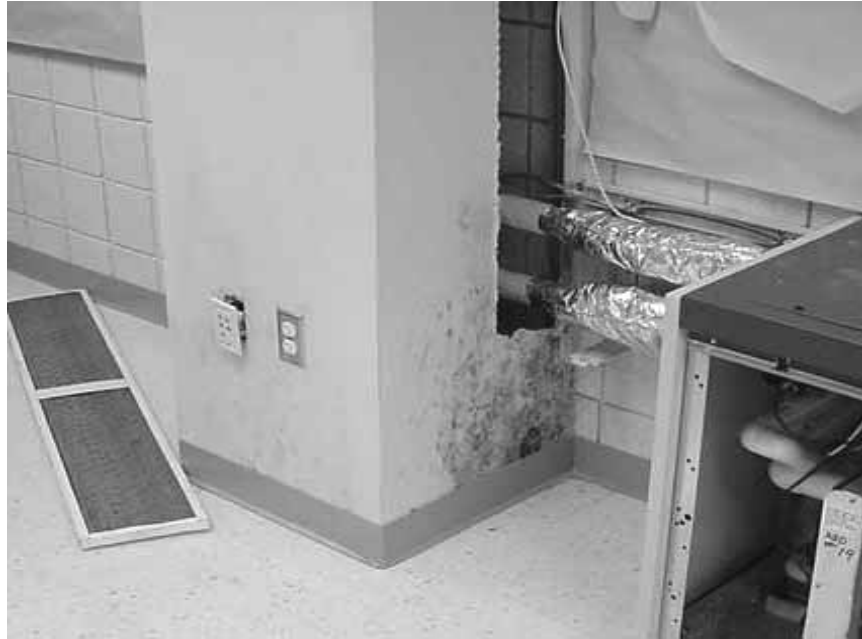
**Picture 3**

**Mold Colonized GW, Note Insulated Univent Pipes**

1. Continue with plans to remove mold-colonized materials, such as pipe insulation, ceiling tiles, and gypsum wallboard. Remediate mold contaminated building materials in a manner consistent with *Mold Remediation in Schools and Commercial Buildings* published by the US Environmental Protection Agency (US EPA) (US EPA, 2001). Copies of this document can be downloaded from the US EPA website at: [http://www.epa.gov/iaq/molds/mold\\_remediation.html](http://www.epa.gov/iaq/molds/mold_remediation.html)

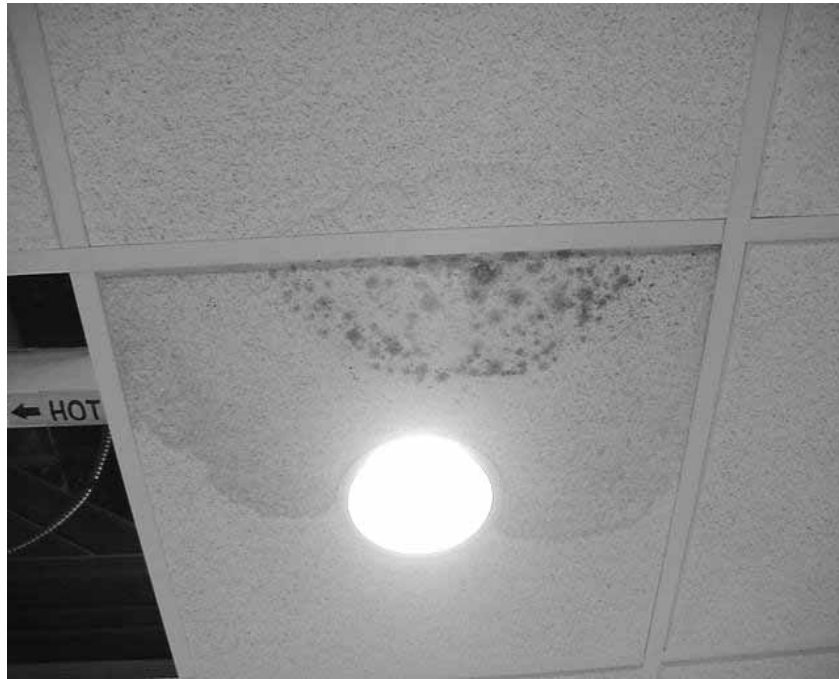
**Picture 4**

**Mold Colonized Ceiling Tiles**

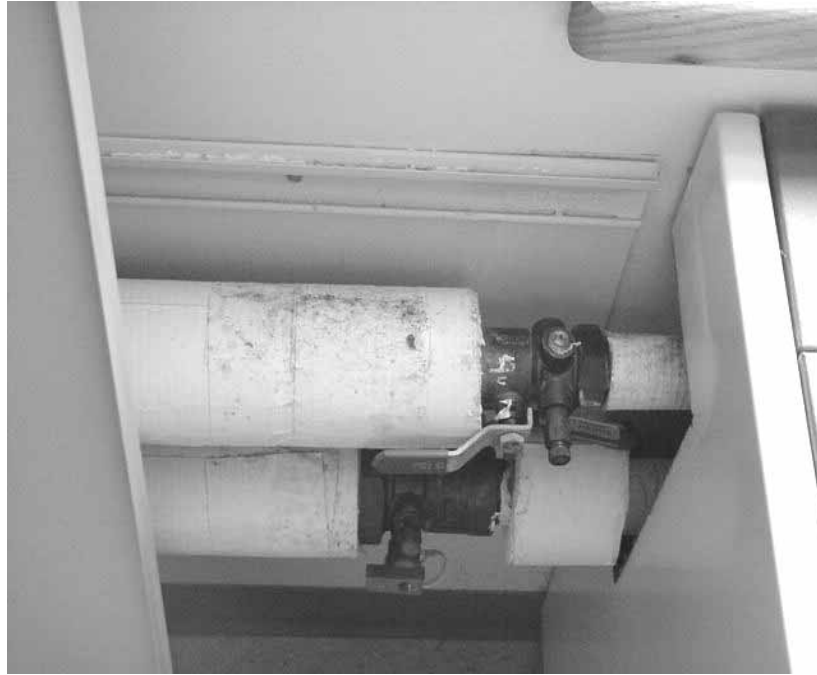
**Picture 5**

Pipe insulation that is moistened for an extended period of time can result in several problems. The exterior wrap is made of a paper material that, if not dried, can serve as a medium for mold growth. In addition, wetting of insulation can degrade its performance, resulting in increased energy costs. Condensation forms if spaces in the insulation exist or the R rating of the insulation is not sufficient. The R rating is a mathematical representation of the ability of insulation to prevent temperature transfer. If an air conditioning system has chilled water pipes with an insufficient R rating, temperature could be transferred to the surface paper, thus creating condensation. Once water wets insulation, a temperature bridge is created, which results in further wetting of insulation and enhancing mold growth.

**Mold Colonized Pipe Insulation**

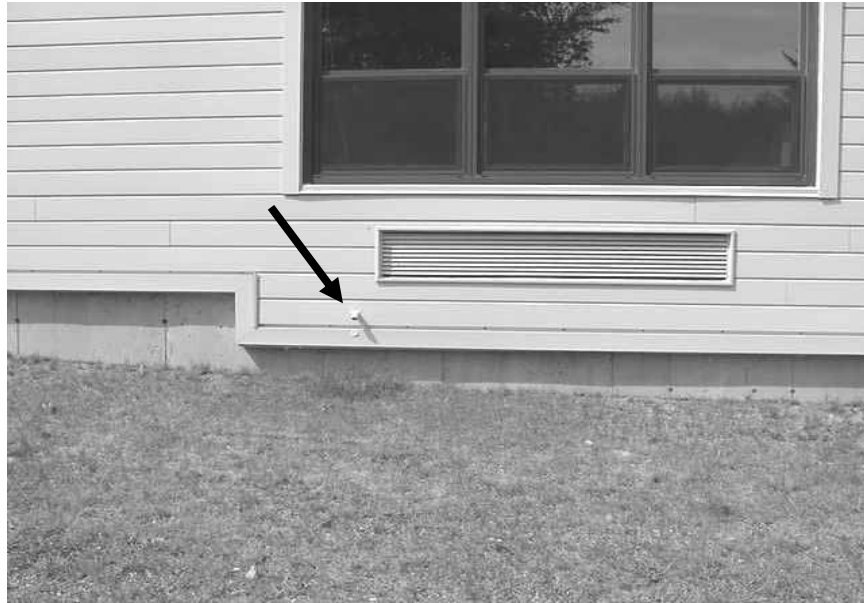
**Picture 6**

Condensate forming on cooling coils can drain into the pan. At the DES, PVC piping installed through the exterior wall provide univent drain pans with a means to drain directly outdoors (Pictures 6 and 7).

**Univent Condensation Drain**

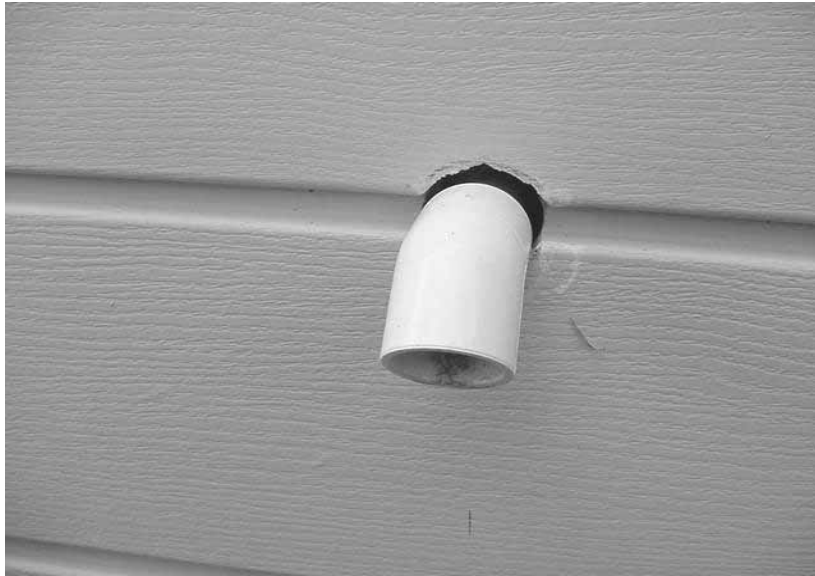
**Picture 7**

As previously discussed, each univent PVC drain passes through the exterior wall. BEHA staff observed spaces around the PVC pipe that can allow moisture to be drawn through the exterior wall by univent fans (Picture 7). This contingency is likely, since the drip pans are located below the univent fans. As fans operate, the area within a univent that is between the fan and air intake vents becomes depressurized. This depressurization can draw outdoor air through unintentional spaces, such as the ones around the univent drains, into the univent cabinet. In this manner, moist, humid air can be drawn into the building

**Condensation Drain, Note Space around PVC Pipe and Lack of Water Draining from Pipe**

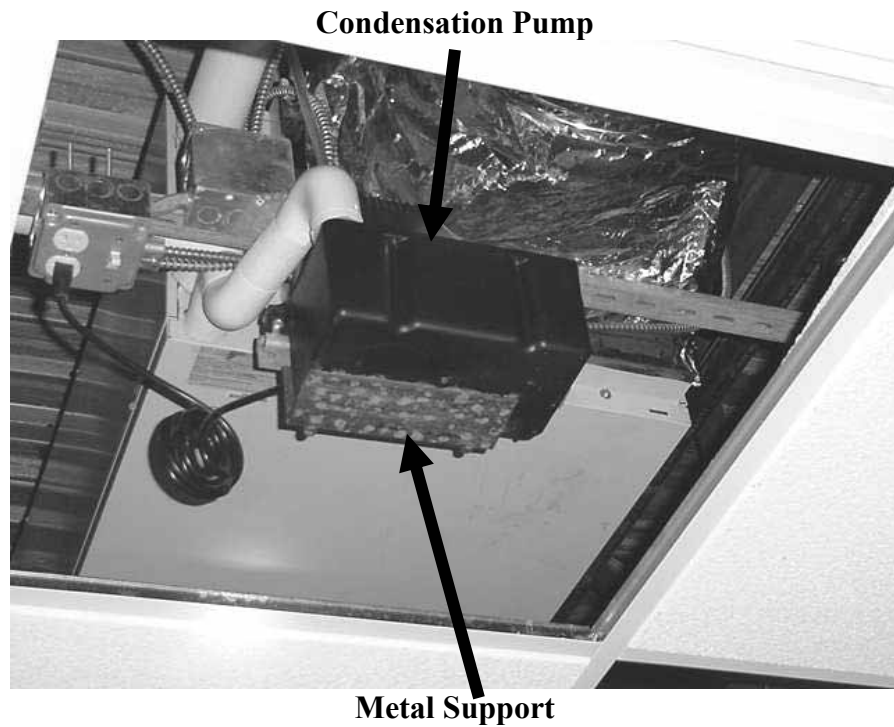
**Picture 8**

Of note was a condensation collection pump system located above the ceiling that services the library's HVAC system (Picture 8). The condensation drain pump is located on a metal support that is heavily corroded. Since neither the condensation

pump nor the metal support is insulated, the temperature of the chilled water from the HVAC system lowers the temperature of the support, making it prone to condensation generation. Once condensation collects on the support, the ceiling tile below becomes chronically moistened. If not allowed to dry, ceiling tiles can serve as a mold growth medium.

**Condensation Collection Pump System Resting On Metal Support, Note Heavy Corrosion on Support**

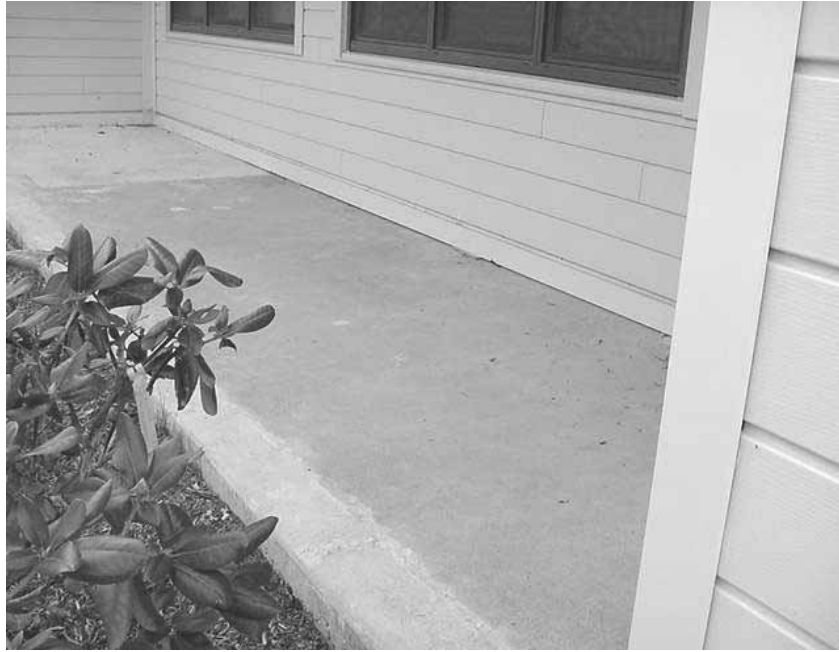
**Picture 9**

Another possible area providing for water penetration is the exterior wall along the sheltered sidewalk outside the art room. A significant seam was observed at the cement/exterior wall junction (Picture 9). This seam appears to be unsealed. Under wet weather conditions, an easterly wind can drive rain into this seam. It is usual building practice to seal this type of seam to prevent water penetration.

**The Cement/Exterior Wall Junction outside Art Room**
